BULLETIN T-64-41

SUBJECT: TRIUMPH TR-4 WINDOW  
WINDER REGULATOR

DATE: DECEMBER 10, 1964

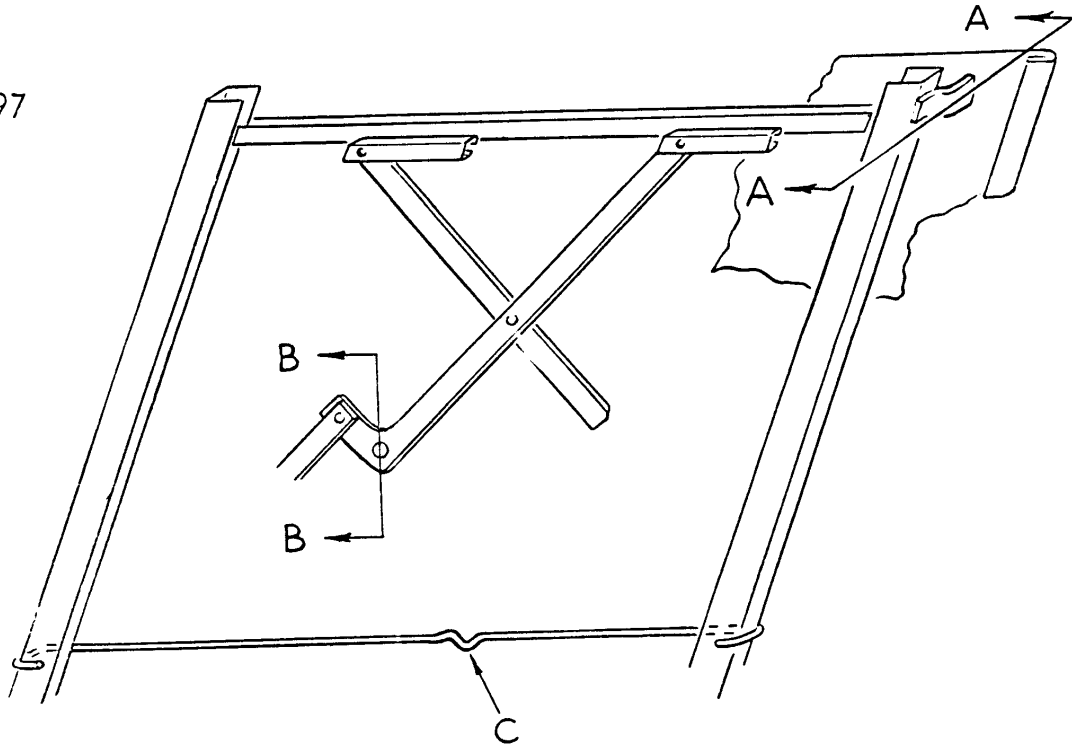
A-A

1. Remove trim panel.
2. Raise window and check the clearance of the glass fore and aft in the top of the rear channel. The recommended clearance is .030" which should be maintained for the whole length of the channel. Excess clearance will allow tilting and the jamming of the glass and insufficient clearance will produce stiff operation. Clearance can be obtained by the use of packing washers between the inner door panel and top channel bracket (see illustration A-A).
