# Replacement Door Glass Part Number V038 TR-4/6

T-72 -C-2 August, 1972

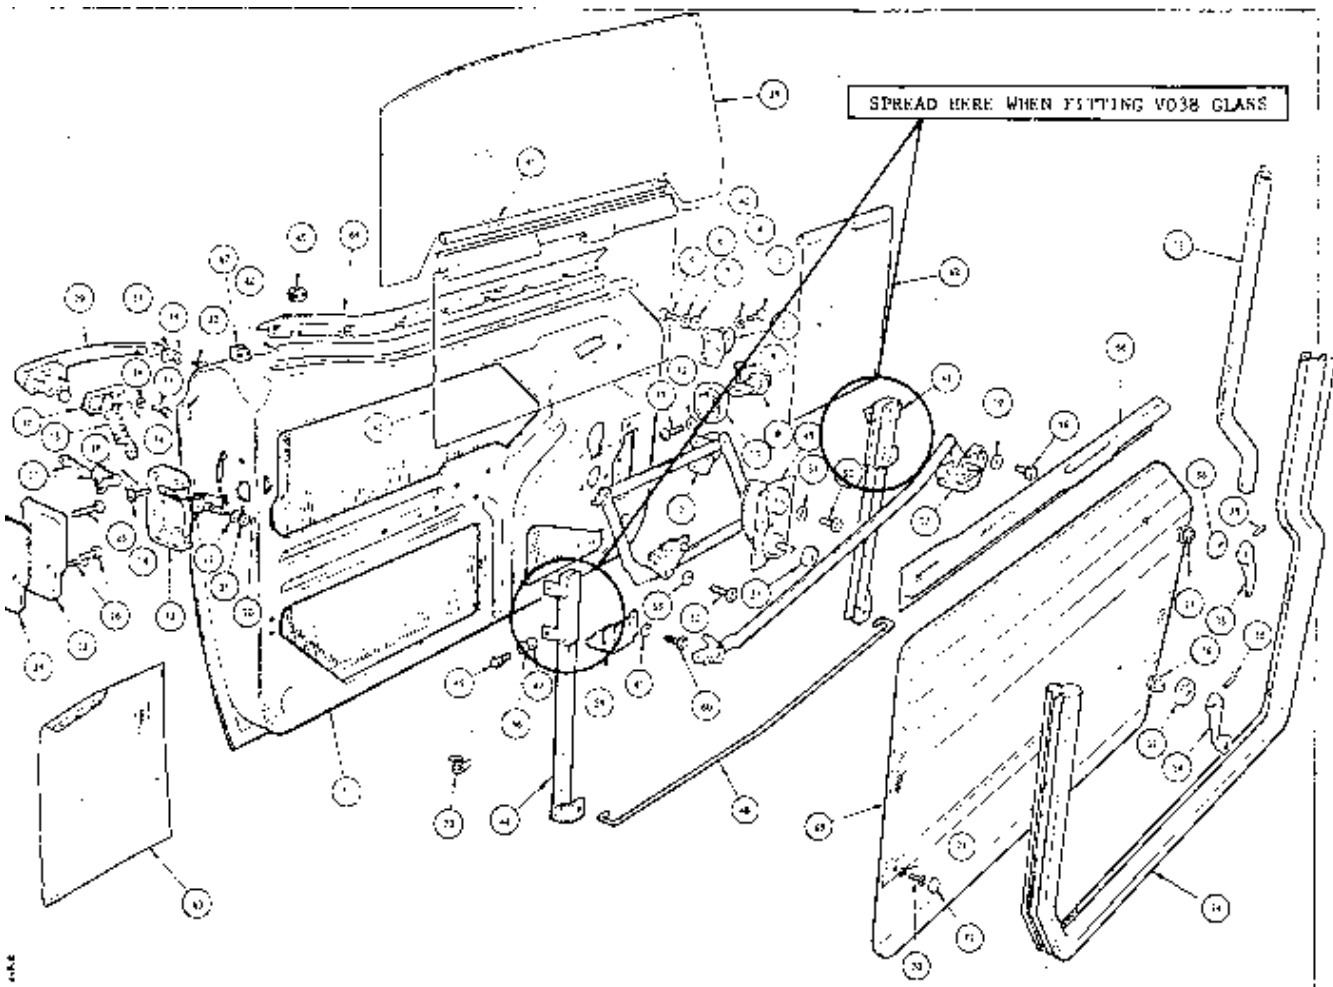
Difficulty has been experienced with the installation of the door glass, part number V038. The reason for this is that the original glass supplied with the vehicle is 0.190" thick, whereas the replacement glass (part number V038) is 0.230" thick. The problem, however, can be overcome by simply spreading the nylon finger clamps on the upper portion of each window channel by inserting a suitable tool such as a screwdriver. It is not necessary to remove the channels from the door.
