STANDARD-TRIUMPH MOTOR COMPANY, INC.

WESTERN ZONE

TO: ALL TRIUMPH DEALERS - WESTERN ZONE

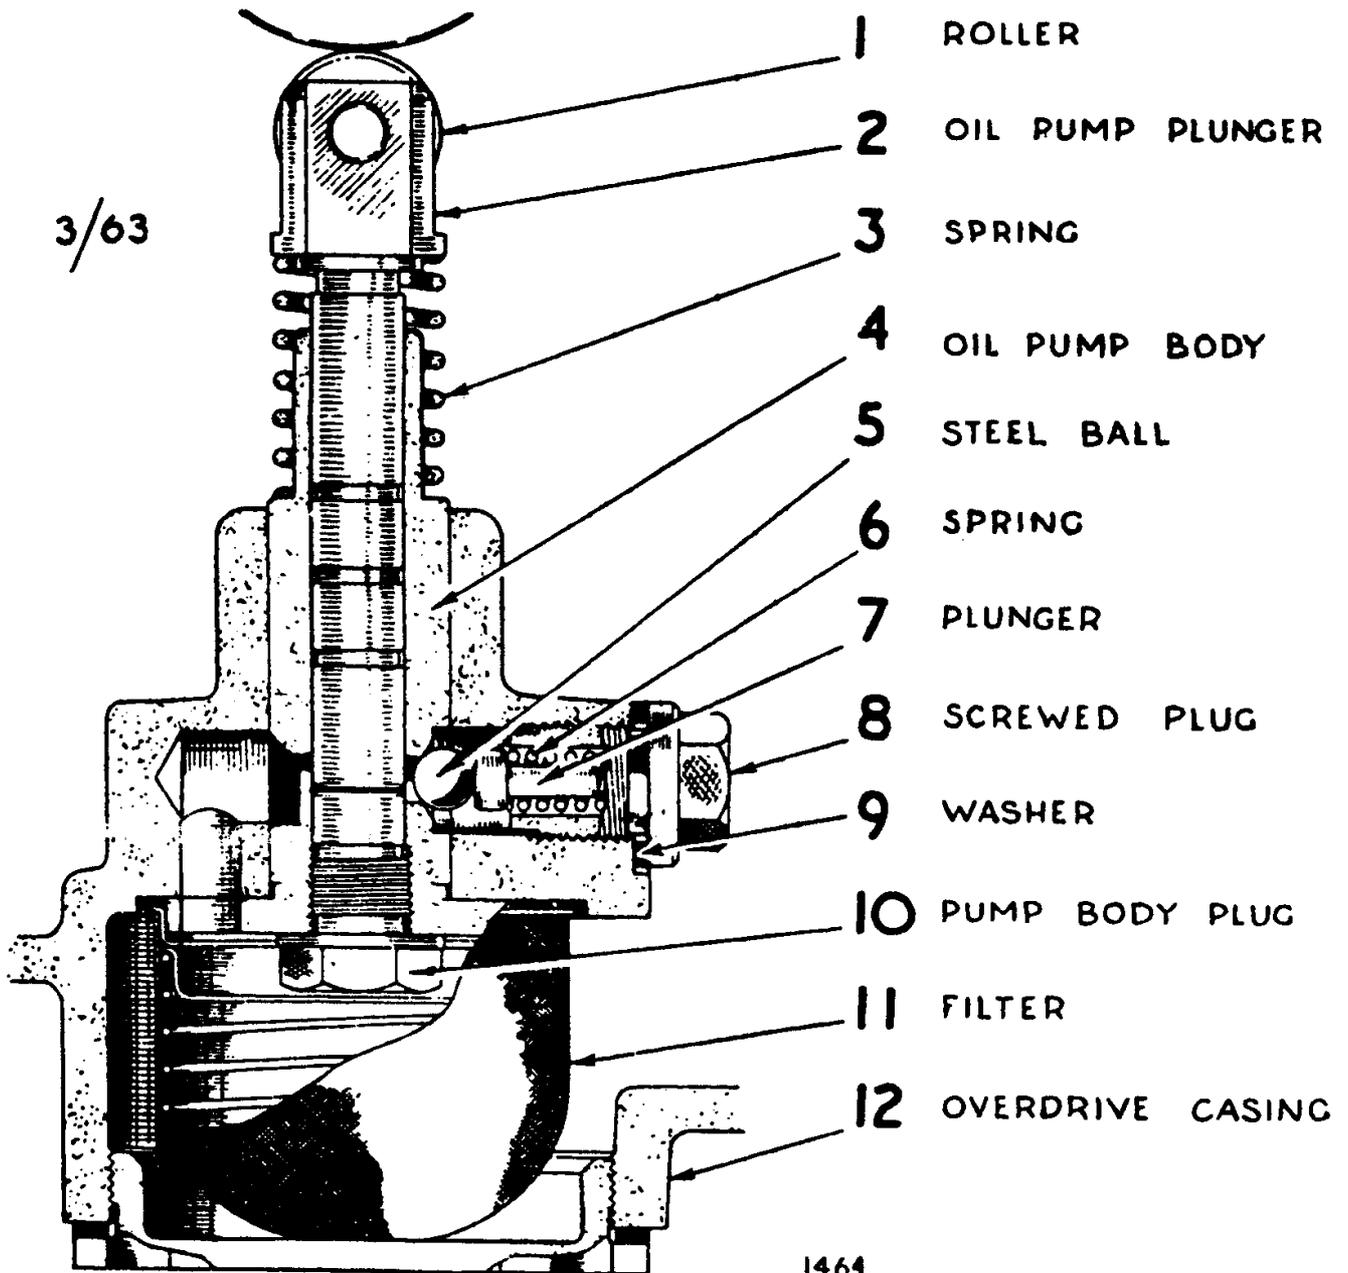
FIG. 1

For adjusting the solenoid on "D" type see Service Bulletin 1-63-60. PUMP NON-RETURN VALVE (Figure 1)

PUMP VALVE
A TYPE ONLY

In "A" type units access to the valve necessitates removal of the solenoid and solenoid bracket. The bracket is secured by two 5/16" (7.937 mm.) diameter studs and two t/16" (7.937 mm.) diameter bolts, the head of the bolts being painted RED. THE NUTS MUST BE REMOVED FROM THE STUDS BEFORE TOUCHING THE BOLTS. The two bolts should not be slackened off together releasing the compression on the accumulator spring which abuts the solenoid bracket.

After removing the valve plug, spring, plunger and ball, clean the seat and reset the ball by giving it a sharp tap with a suitable hammer and drift.

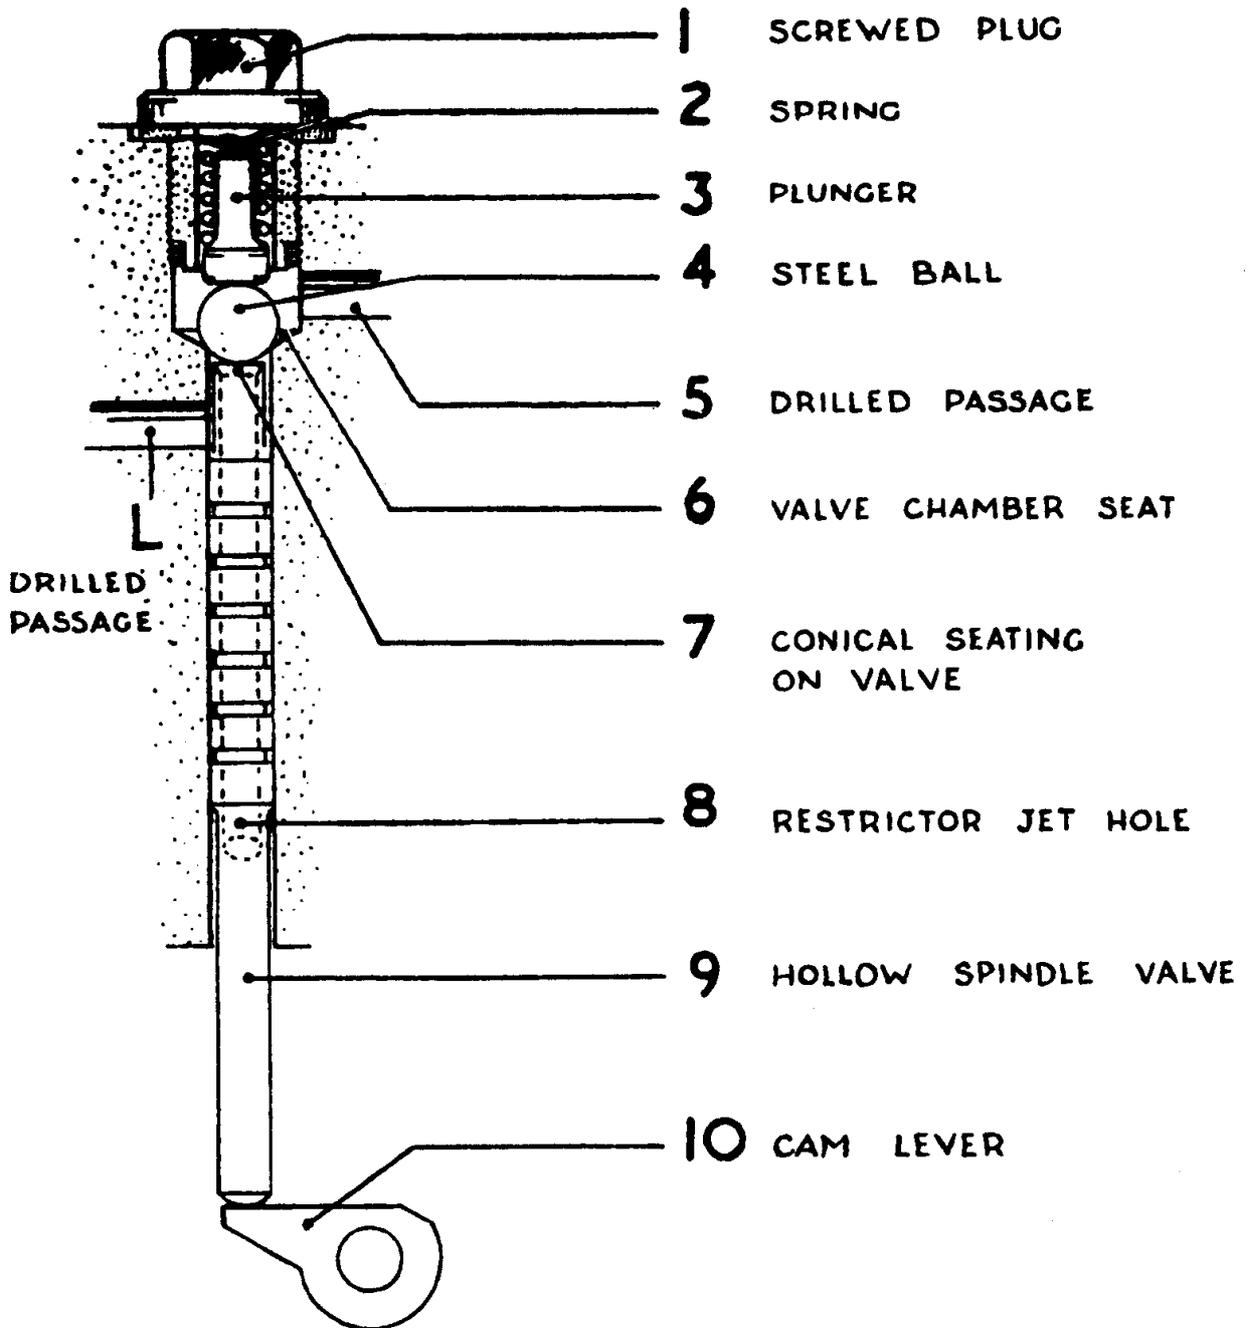
FIG. 2

The operating valve plug is located on top of the unit. Release hydraulic pressure, unscrew plug and remove spring, plunger and ball. A small magnet will be found useful for this operation. Remove operating valve by inserting a stiff piece of wire and drawing it up. Near the bottom of the valve will be seen a small hole breaking through the center drilling. Ensure that this is not choked (Figure 2).

OPERATING VALVE
A AND D TYPE

If necessary, the ball can be resealed on top of the operating valve by placing the ball on a block of wood and sharply tapping the valve after positioning it on the ball. Clean the valve seat in the casing and if necessary reseat the ball by tapping it gently on its seat with a copper drift. Do not tap the ball too hard or the mouth of the hole will be closed up so that the valve cannot be reassembled.

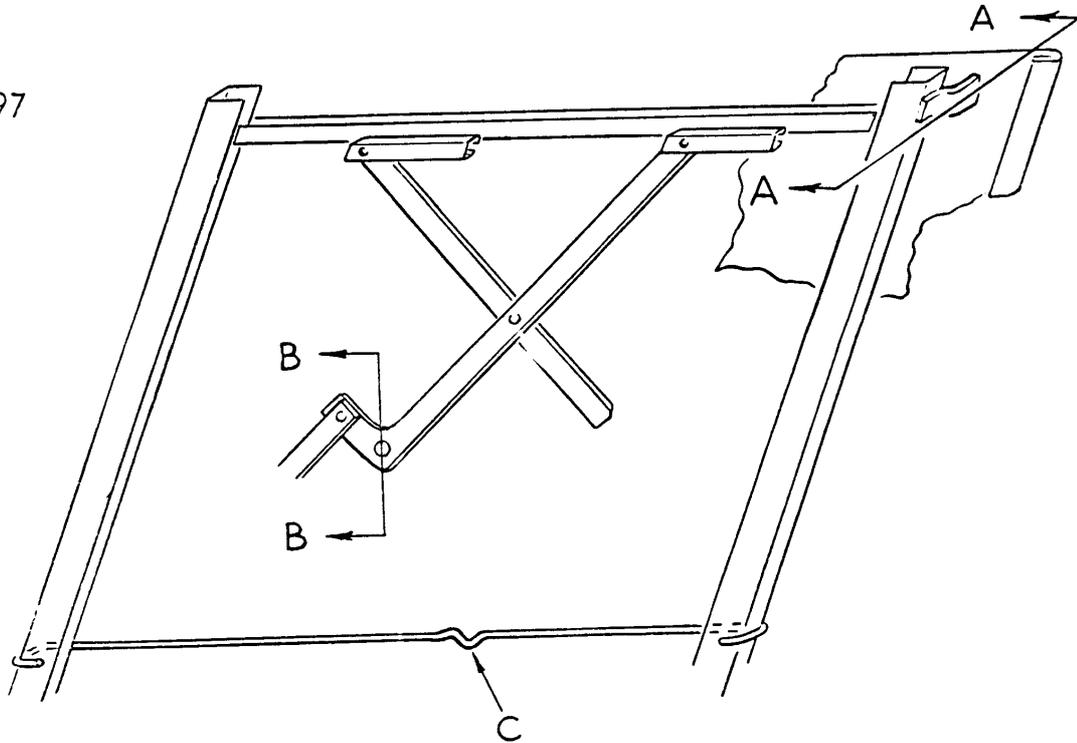
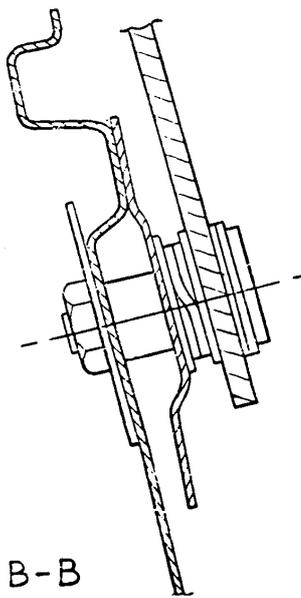
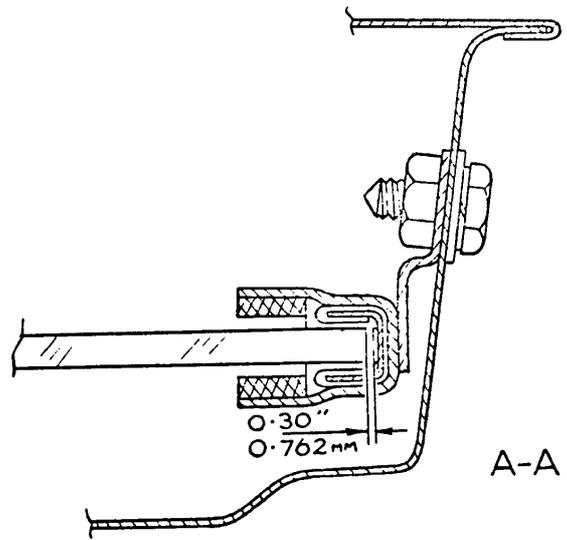
When reports of stiffness in the operation of the door glass are received, the following procedure should be adopted which will prevent straining and damage to the regulator. The same instructions should also be followed when renewing a regulator.

1. Remove trim panel.
2. Raise window and check the clearance of the glass fore and aft in the top of the rear channel. The recommended clearance is .030" which should be maintained for the whole length of the channel. Excess clearance will allow tilting and the jamming of the glass and insufficient clearance will produce stiff operation. Clearance can be obtained by the use of packing washers between the inner door panel and top channel bracket (see illustration A-A).

3. Adjust bottom brackets and crimp the tie rod to ensure that the channels are parallel (illustration C).
4. Remove regulator pivot pin nut and delete spring washer under head of nut. Add washer WP0119 1/2"x 7/8" x .050" behind head of pivot bolt and additional washer WP0160 5/16" x 1 5/8" x 16 S.W.G. behind head of nut (illustration B-B).

5. Tighten nut sufficiently to allow ease of operation and peen or center pop end of thread.
6. Refit trim.

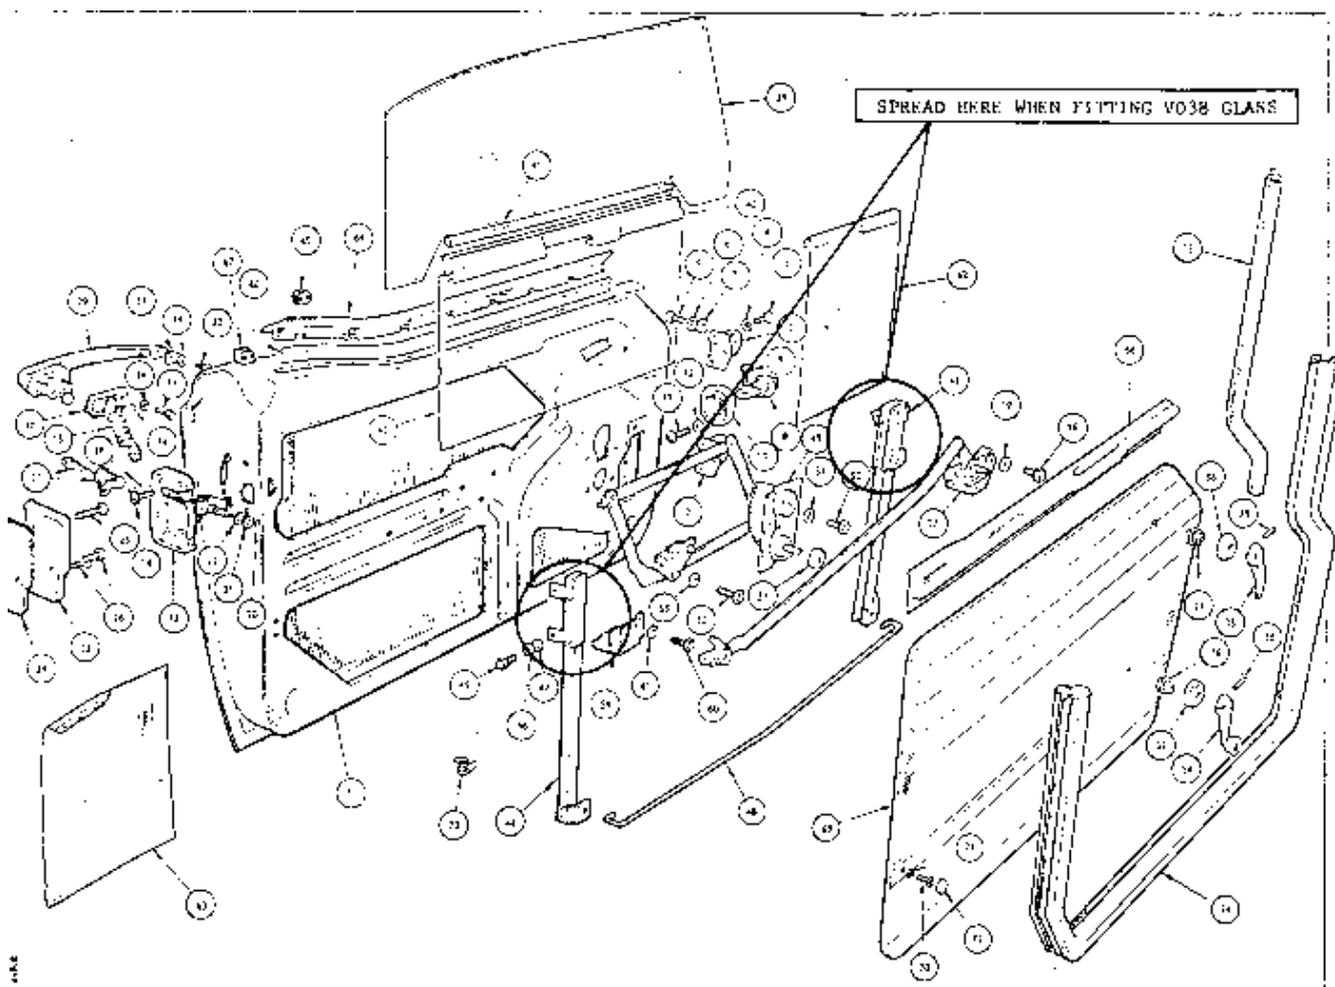
Replacement Door Glass Part Number V038 TR-4/6

The reason for this is that the original glass supplied with the vehicle is 0.190" thick, whereas the replacement glass (part number V038) is 0.230" thick. The problem, however, can be overcome by simply spreading the nylon finger clamps on the upper portion of each window channel by inserting a suitable tool such as a screwdriver. It is not necessary to remove the channels from the door.
